Confidential Inspection Report

Prepared by: Accu-Check Home Inspection
2348 Beecham Place North
Cordova, TN 38016
901-383-4333

ADDRESS: 8107 North Pole.

DATE: 12/06/2014.

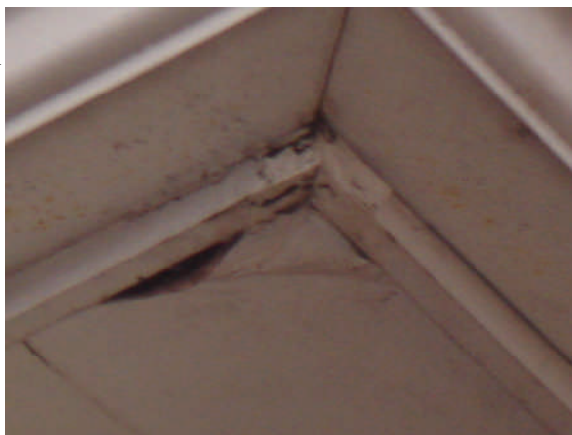
Wood. Deterioration noted at: left side and right side rear at drip edge. Rot noted at fascia and soffit at front left corner. Fascia rotted at center rear at second level at roof union. Recommend review/repair as needed.

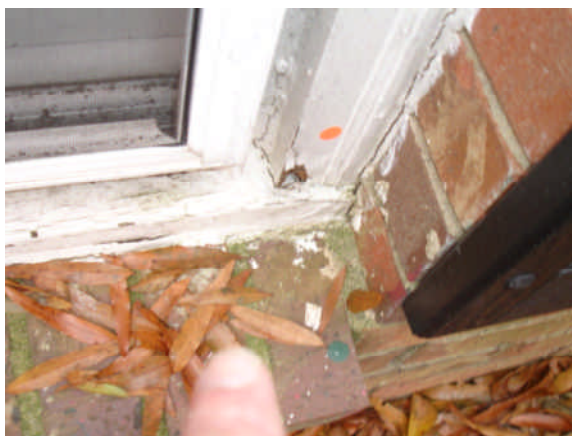
106 WINDOWS: Type: Wood. Spot deterioration noted at all windows at front. Recommend repair as needed.

Spot deterioration noted at all windows at front. Recommend repair as needed.

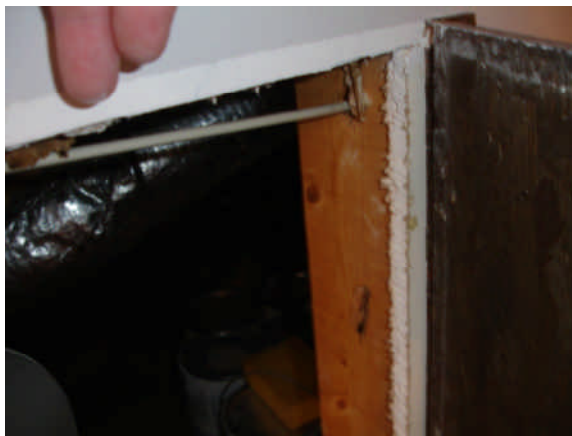
- 401 ACCESS:** Located at: Bedroom. Accessed. Weatherstripping missing at small attic access door. Attic walk door binds. Recommend to repair as needed.

Located at: Bedroom. Accessed. Weatherstripping missing at small attic access door. Attic walk door binds. Recommend to repair as needed.

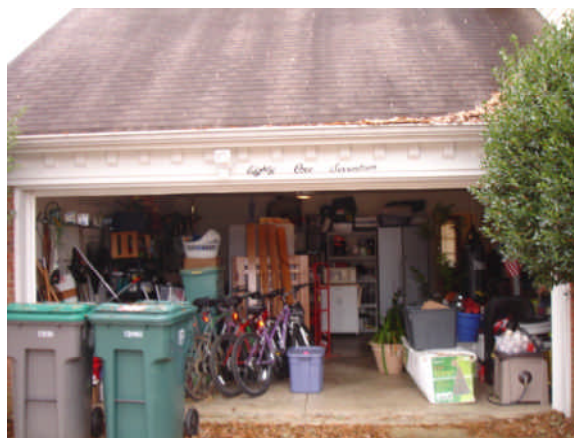
505 FLOOR/SLAB: Concrete. Limited review due to debris.

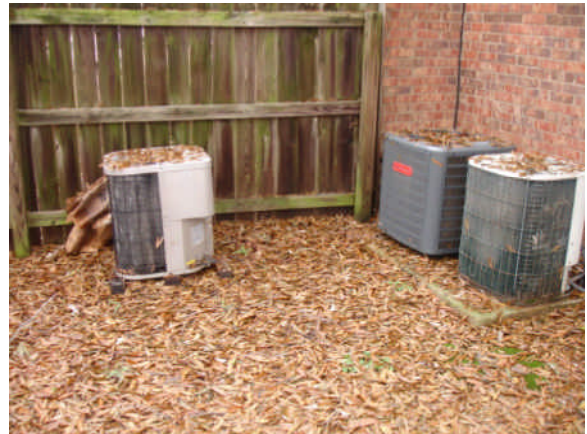
There is an old AC unit at the back yard.
Recommend to remove.

There is an old AC unit at the back yard. Recommend to remove.

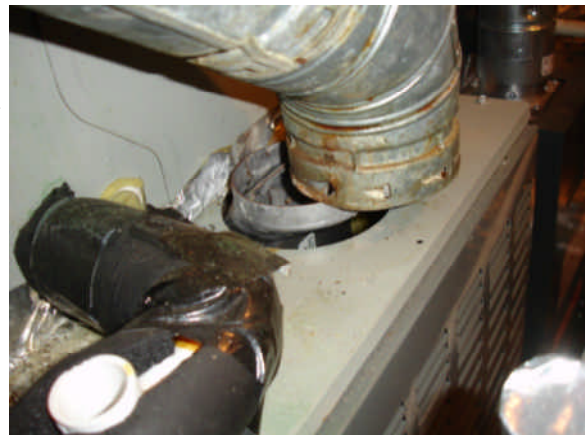
Loose/disconnected/negative sloped or poorly fitting vent pipes will allow products of combustion to escape. This is a safety concern. Recommend review/repair by HVAC contractor.

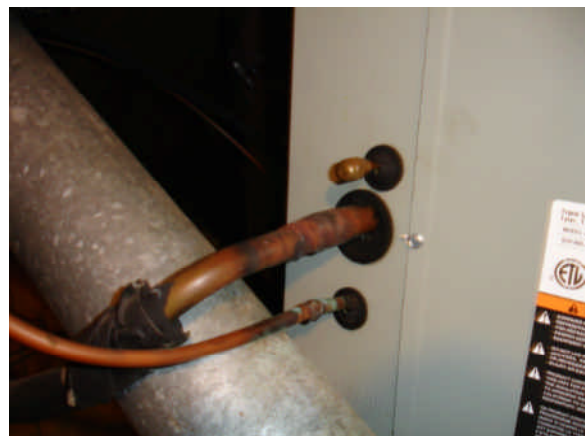
Intact where visible. Recommend to replace the missing freon line insulation at the attic area.

Recommend to replace the missing freon line insulation at the attic area.

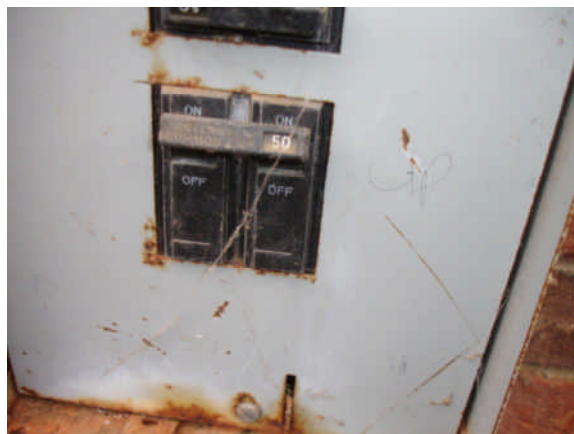
As most manufacturers warn against operating air conditioning units when the outside temperature is under 65 degrees, this unit was not tested. Recommend verifying operation with HVAC contractor when temperature allows. The newer AC unit was overfused at the disconnect box. The max breaker size on the manufacturers plate is 25 amps. Recommend review/repair or replacement by a qualified air conditioning contractor.

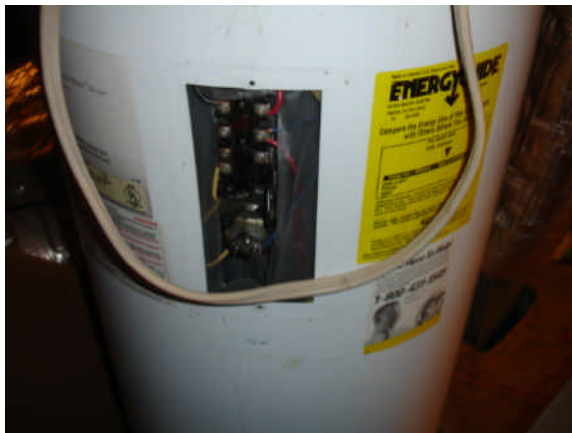
1014 ADD'L CMTS: Cover plates missing at elements.
Recommend repair as needed by licensed plumber.

Cover plates missing at elements. Recommend repair as needed by licensed plumber.

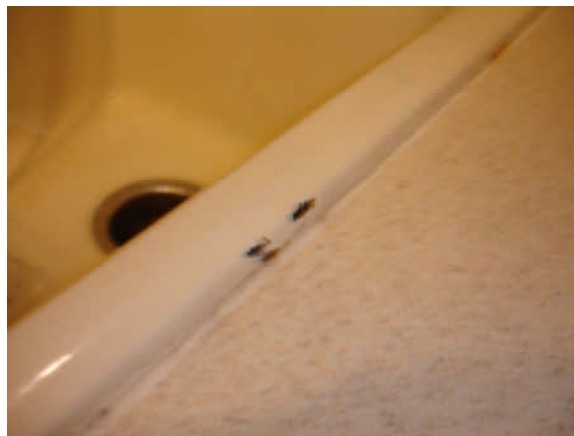
1301 FLOORS: Serviceable.
1302 WALLS: Serviceable.
1303 CEILINGS: Serviceable.
1304 DOORS: Serviceable.
1305 WINDOWS: Serviceable.
1306 CABINETS: Serviceable.
1307 COUNTER
TOPS: Serviceable.
1308
ELECTRICAL: Serviceable.
1309 SINK: Chipped. Recommend to repair as needed.

Chipped. Recommend to repair as needed.

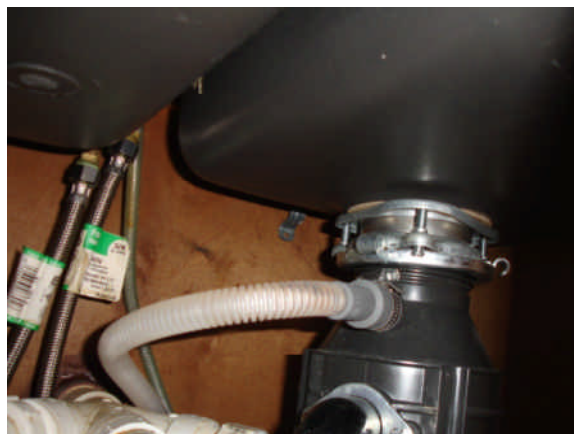
DISHWASHER: Dishwashers most commonly fail internally at the pump, motor or seals. We do not disassemble these components. If unit is operable and power is supplied, our inspection is limited to operating the unit on the normal wash cycle only. Therefore, it is advisable to operate this unit prior to closing. No high loop in the dishwasher drain line. This is installed to keep water from flowing into the dishwasher when disposal backs up. Recommend to repair.

No high loop in the dishwasher drain line. This is installed to keep water from flowing into the dishwasher when disposal backs up. Recommend to repair.

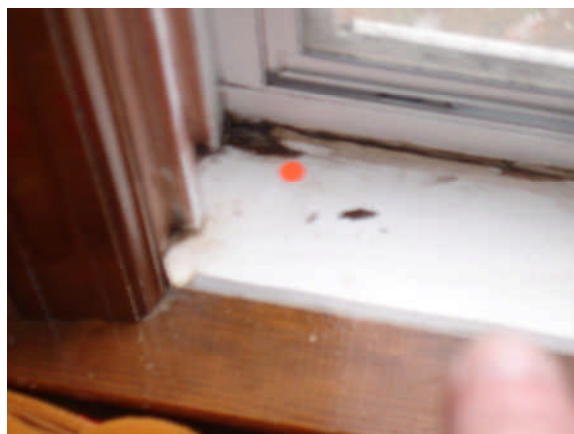
1506 WINDOWS: Wood rot noted at front window.
Recommend review/repair as needed.

Wood rot noted at front window. Recommend review/repair as needed.

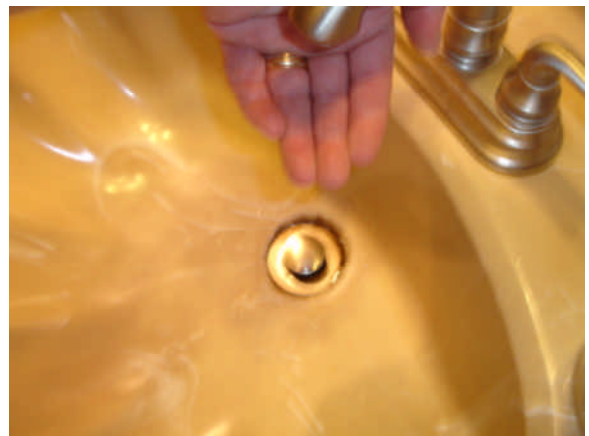
- 2202.1 FLOORS: Serviceable.
- 2203.1 WALLS: Serviceable.
- 2204.1 CEILINGS: Serviceable.
- 2205.1 DOORS: Serviceable.
- 2206.1 ELECTRICAL: Serviceable.
- 2207.1 WINDOWS: Serviceable.
- 2209.1 HEAT SOURCE: Present.
- 2217.1 SINK: Serviceable.
- 2218.1 SINK FAUCET: Faucet leaks. Recommend repair.

Faucet leaks. Recommend repair.

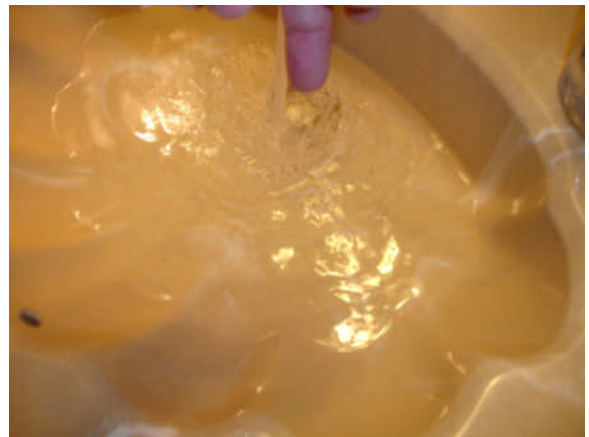
- 2219.1 SINK STOPPER: Drains slowly. Recommend repair.

Drains slowly. Recommend repair.

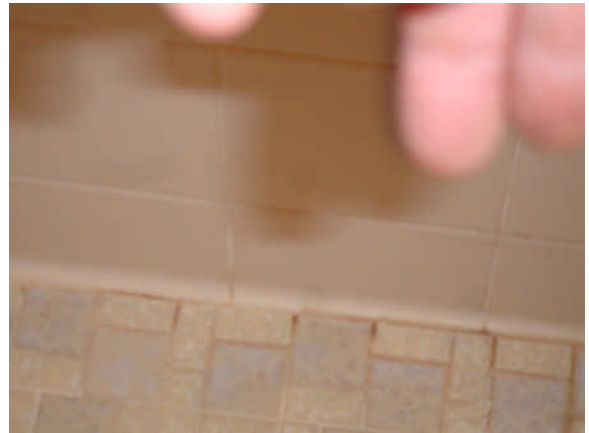
- 2201.2 BATH LOCAT:** Master bedroom.
- 2202.2 FLOORS:** Serviceable.
- 2203.2 WALLS:** Serviceable.
- 2204.2 CEILINGS:** Serviceable.
- 2205.2 DOORS:** Serviceable.
- 2206.2 ELECTRICAL:** Serviceable. Ground Fault Interrupter inoperable/missing at whirlpool tub at time of inspection. Recommend review/repair as needed by licensed electrician.
- 2207.2 WINDOWS:** Serviceable.
- 2209.2 HEAT SOURCE:** Present.
- 2210.2 TUB/SURROUND:** Serviceable.
- 2212.2 TUB FAUCET:** Serviceable. Operated. Functional water flow noted.
- 2213.2 TUB STOPPER:** Serviceable.
- 2214.2 SHOWER/SURROUND:** Recommend caulking/sealing.

Recommend caulking/sealing.

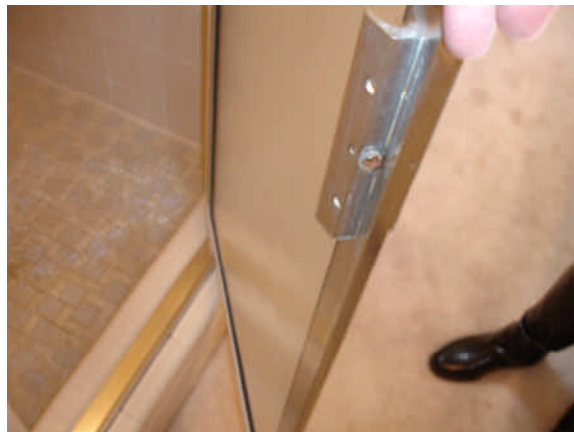
DOOR: Door latch inoperable. Recommend repair.

Door latch inoperable. Recommend repair.

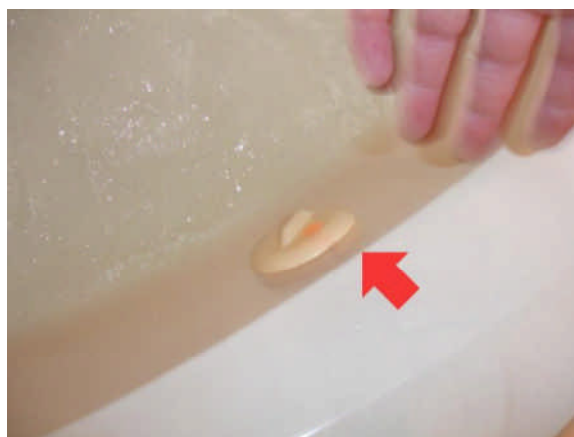
2223.2 SPA/TUB: Air valve inoperable. Recommend repair as needed by licensed plumber.

Air valve inoperable. Recommend repair as needed by licensed plumber.
